# Modern analysis methods for Estonia investigations

-vital areas to investigate

Lars Ångström Former MP and former member of the Standing Committee of Defence

Björn Arvidsson Development engineer and Technical consultant

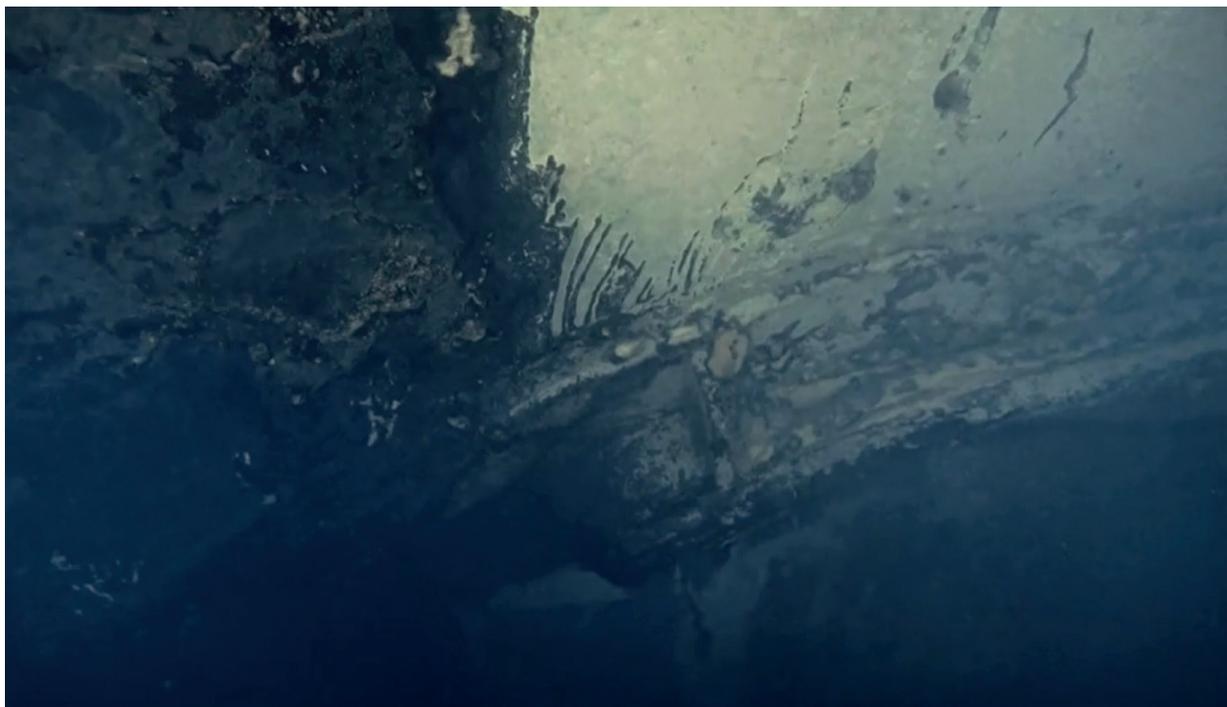
Estonia film by Monster: Fyndet som ändrar allt, 5 Part: Demolished fender bar in damaged area on starboard side with the white painted surface to the right and a blackened surface to the left.

It is important for investigators to simulate a direct hit on the fender bar just behind the original position of the protruding steel parts. It could be the case that a foreign object hit the Estonia from somewhere to the rear of this impact point on the fender bar. The object forced the steel part out from the ship. The object simultaneously knocking, by the impact force, the rest of the fender bar and the side of the hull inwards 1,2 meters.

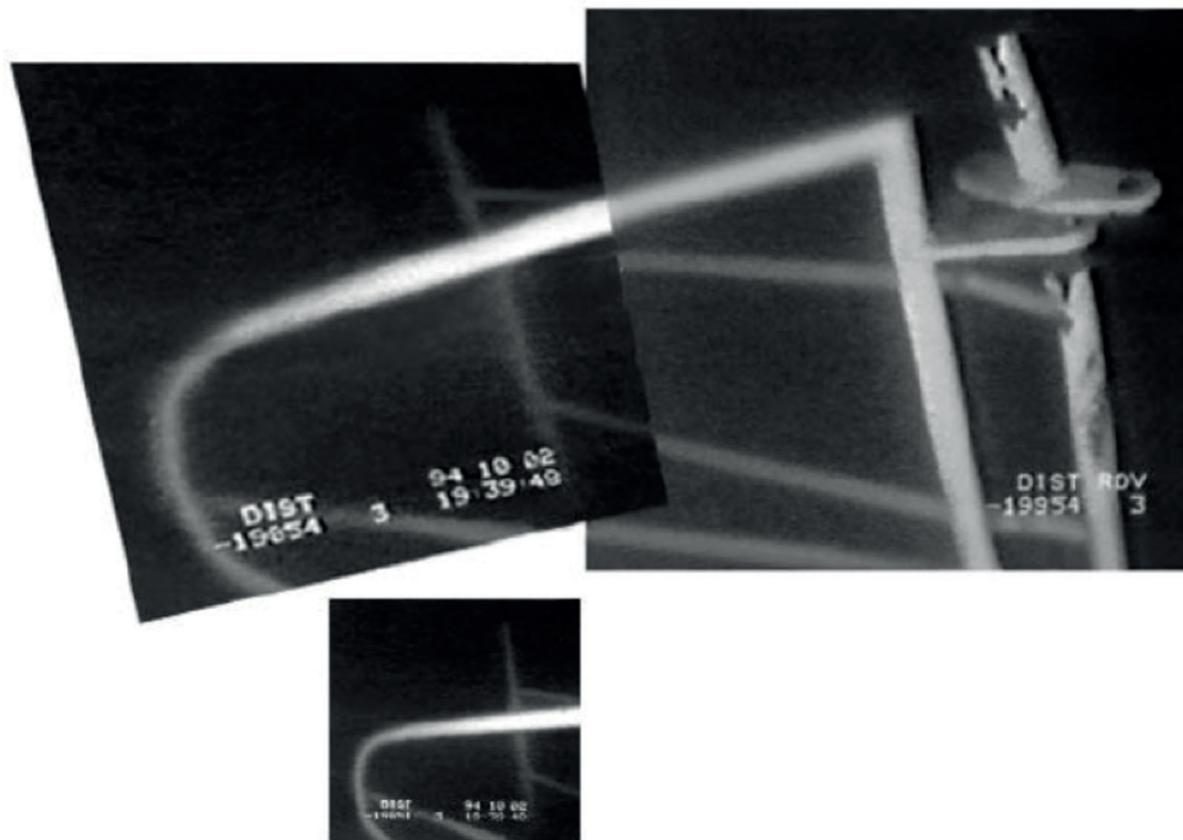
Photos below from film sequences show the railings on the car ramp that have been detached from the closed ramp sometime between the 28th of September and the 2nd of October. As clearly visible on film these railings are standing on the sea floor next to the Estonia which has been confirmed by analysis of the Swedish SKL, Statens kriminaltekniska laboratorium.

Photo: The railings from the closed ramp standing on the bottom outside the wreck filmed by a ROV camera 2nd of October. Collage by Independent Fact Group<sup>11</sup>

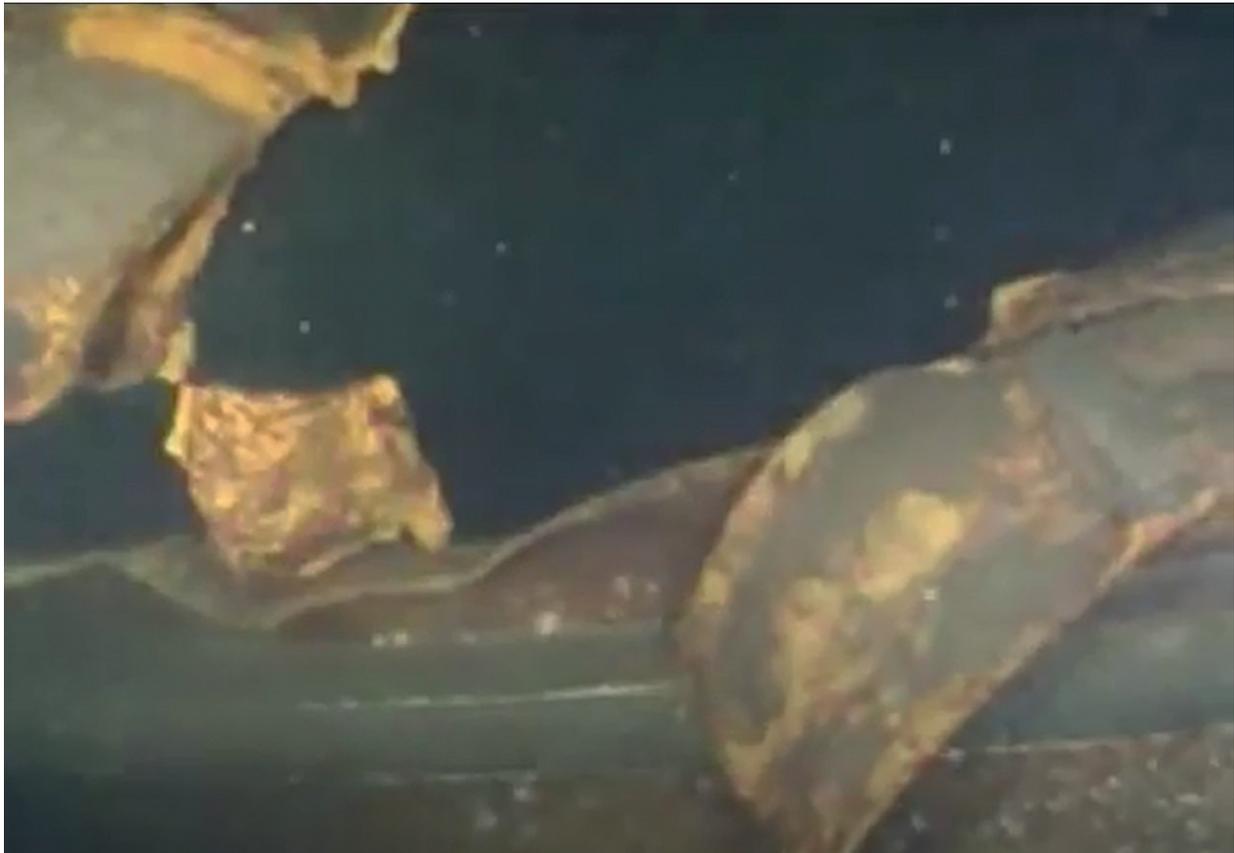
Films from Bemis/Rabe expedition showing the front bulkhead with big holes. Fractured/blown open plates with petals are shown 13 minutes into the film. The quality of this film material is very good compared to the earlier Swedish film material. This film material was produced in 2000.

Film sequence<sup>12</sup> at 13 minutes 29 seconds with what the German group of experts say is a bigger hole from an explosion in a bulkhead. From Documentary: Estonia Jutta Rabe.

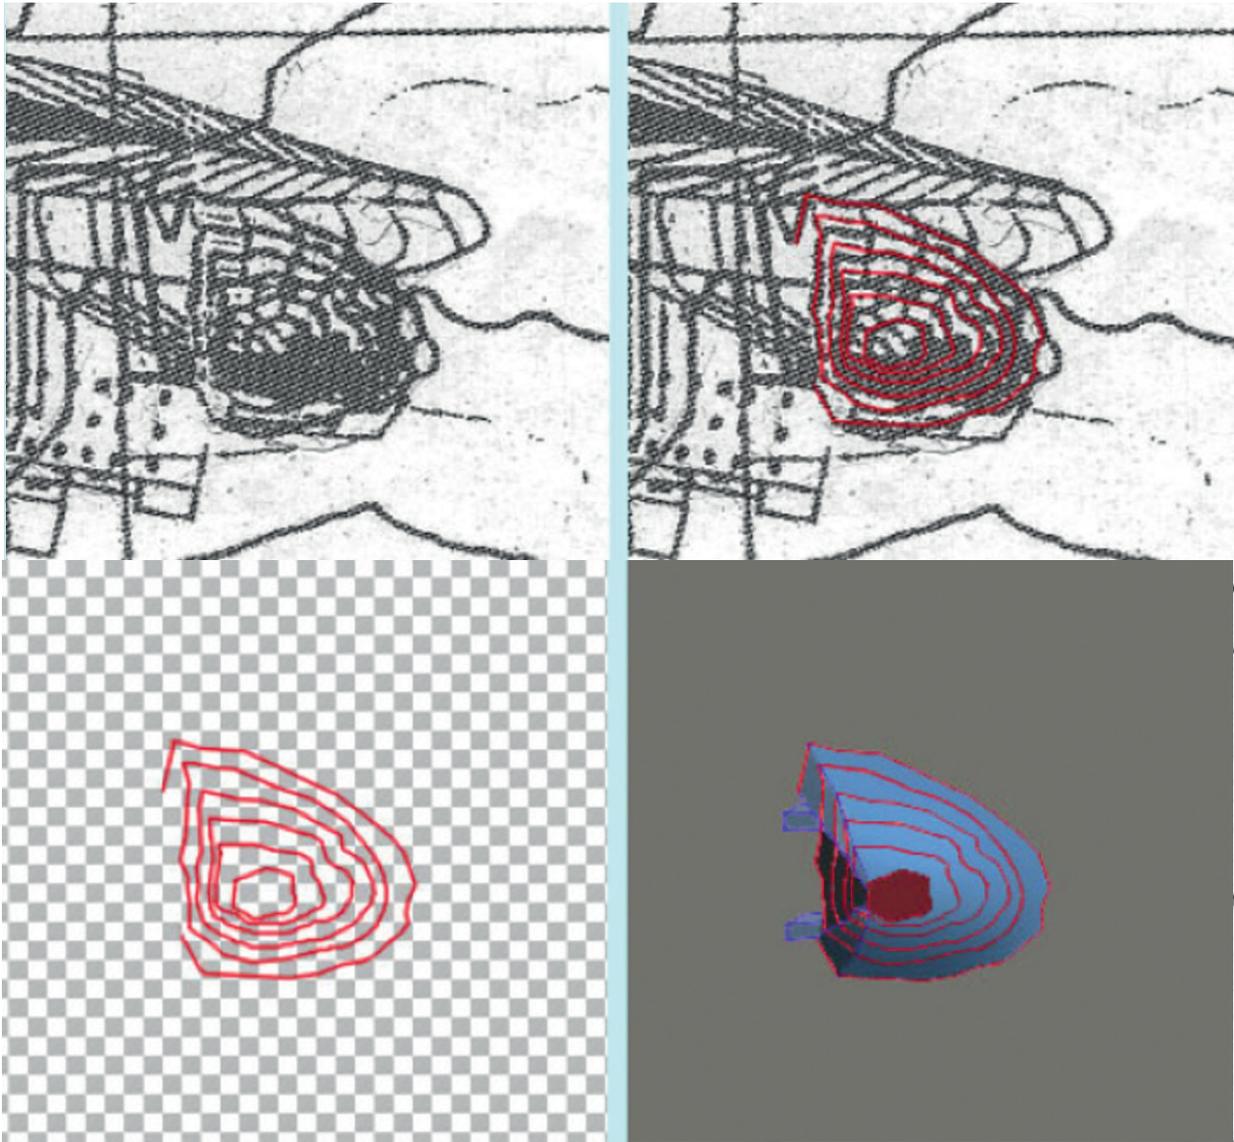
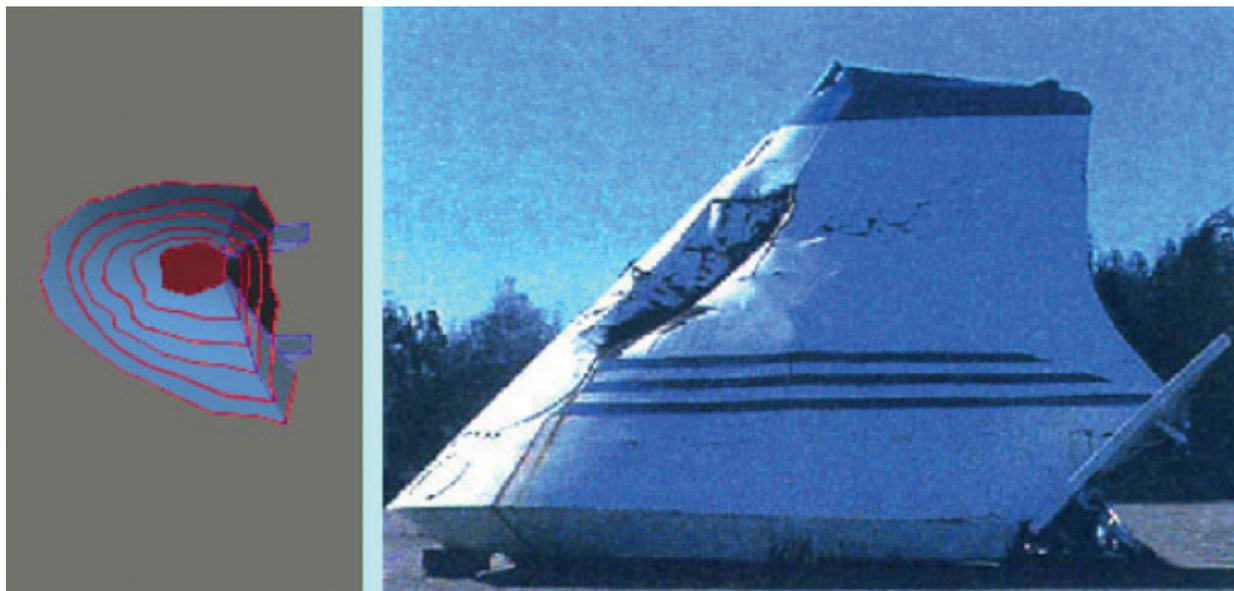
The sonar picture above also serves to illustrate the damage to the starboard side of the visor, Heavy impact through collision with the bulbous bow or alternative? The picture above also shows a damage on the starboard side that is not present on the sonar picture to the left. A big part of the steel hull has been bent outwards from the visor. This damage needs to be analyzed and also the force needed to bend this part of the visor with FEM analysis. A new investigation needs to clarify when this damage occurred.

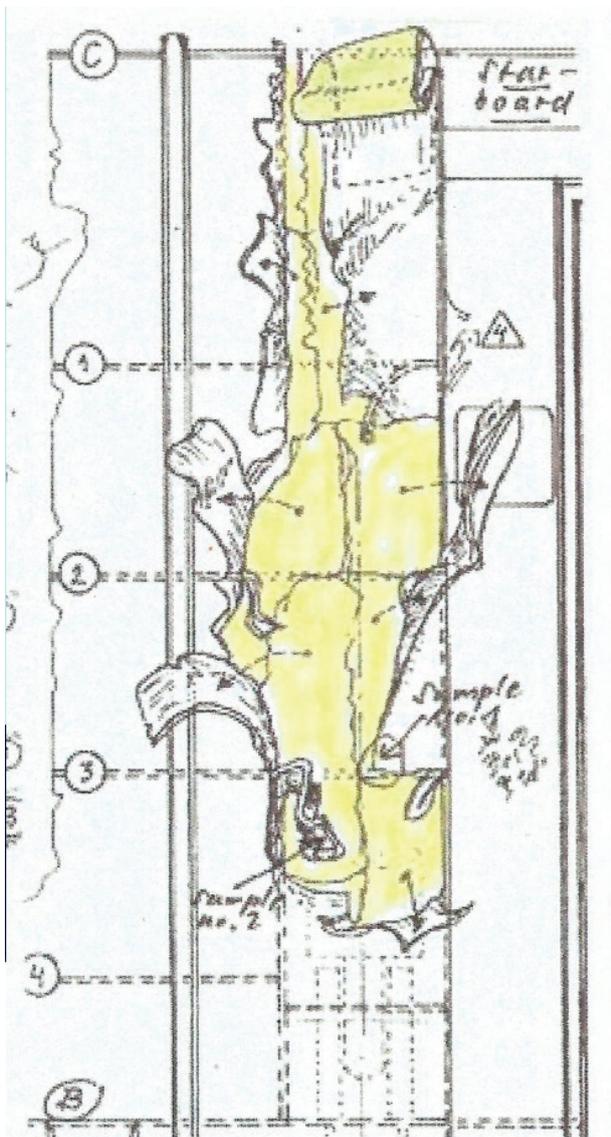
Hole in front bulkhead

- Materialprüfungsanstalt Brandenburg examined the samples and concluded that they had been exposed to an explosion. The plastic deformation in some areas of the steel samples indicate very strong shock effect. This is a typical example of the effects caused by an explosion.
- The American Southwest Research Institute did a similar examination and came to the same conclusion.

- BAM, Bundesanstalt für Materialforschung und -prüfung assert in their report that there were no traces of explosion. The report was criticized for not having examined the side of the steel plates facing the explosion and maintained that the surface changes on the steel plate samples were due to the material having been steel ball blasted. This in spite of previous information from The Meyer Werft shipyard that all steel plates in the ship had been sand blasted.
- Cranfield Military University in the UK did the last examination of the samples and found evidence of an explosion.
- Institute für Materialprüfung und Werkstofftechnik conclude that changes in the material of the samples were caused by explosion or a projectile.
- RCMS Royal Military College of Science in England concluded that the metal samples from Estonia's bulkhead showed traces of explosions.

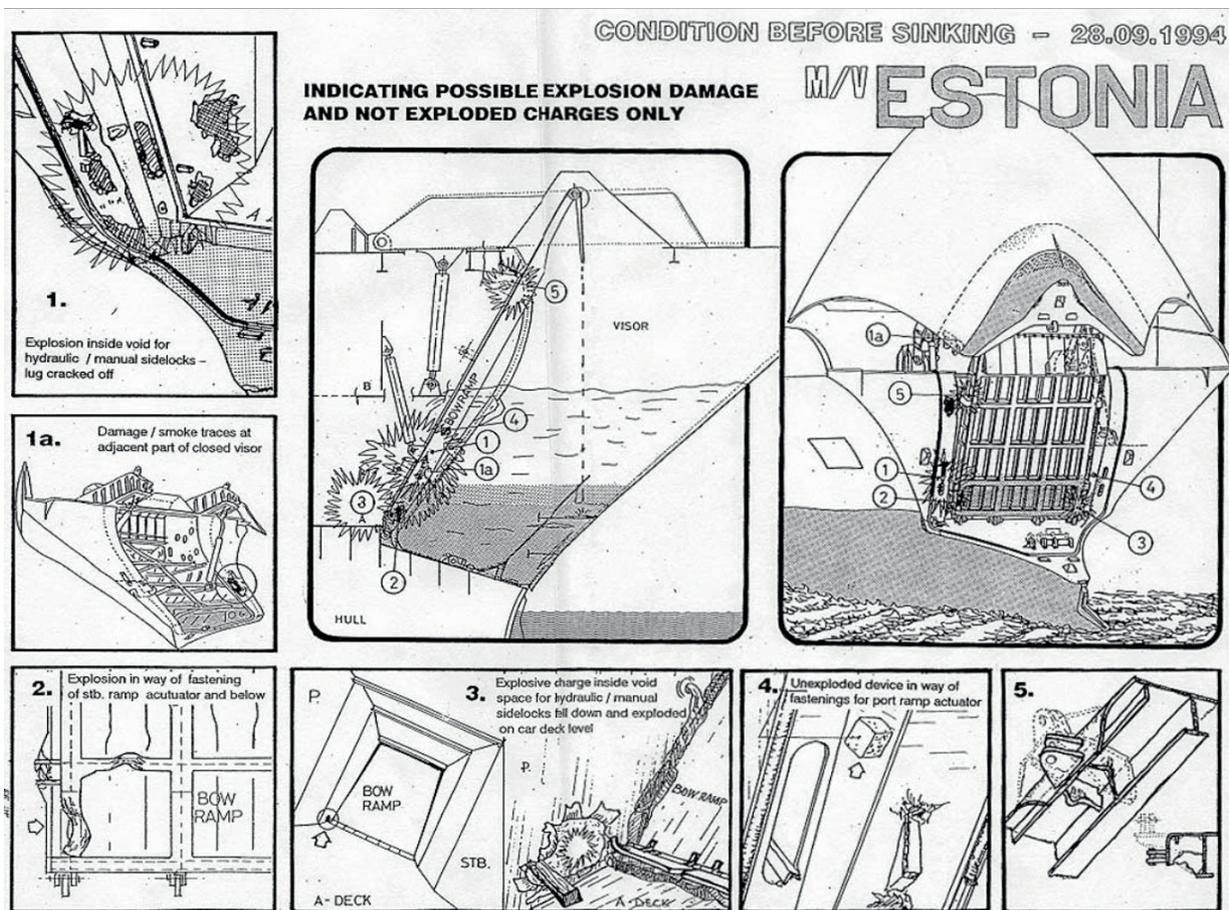
Graphic presentation of documented explosions from the GGE investigation

These graphics also show the positions in the bow and on car deck of the wreck that need to be scanned with photogrammetry to create a 3D model with a minimum 3 mm resolution. Modern tools for analysis, that can calculate the exact forces causing deformations, will be needed to investigate this damage. There are conclusions in the GGE report<sup>17</sup> and in the JAIC report<sup>18</sup> that need to be confirmed or rejected by thorough scanning and 3D analysis.

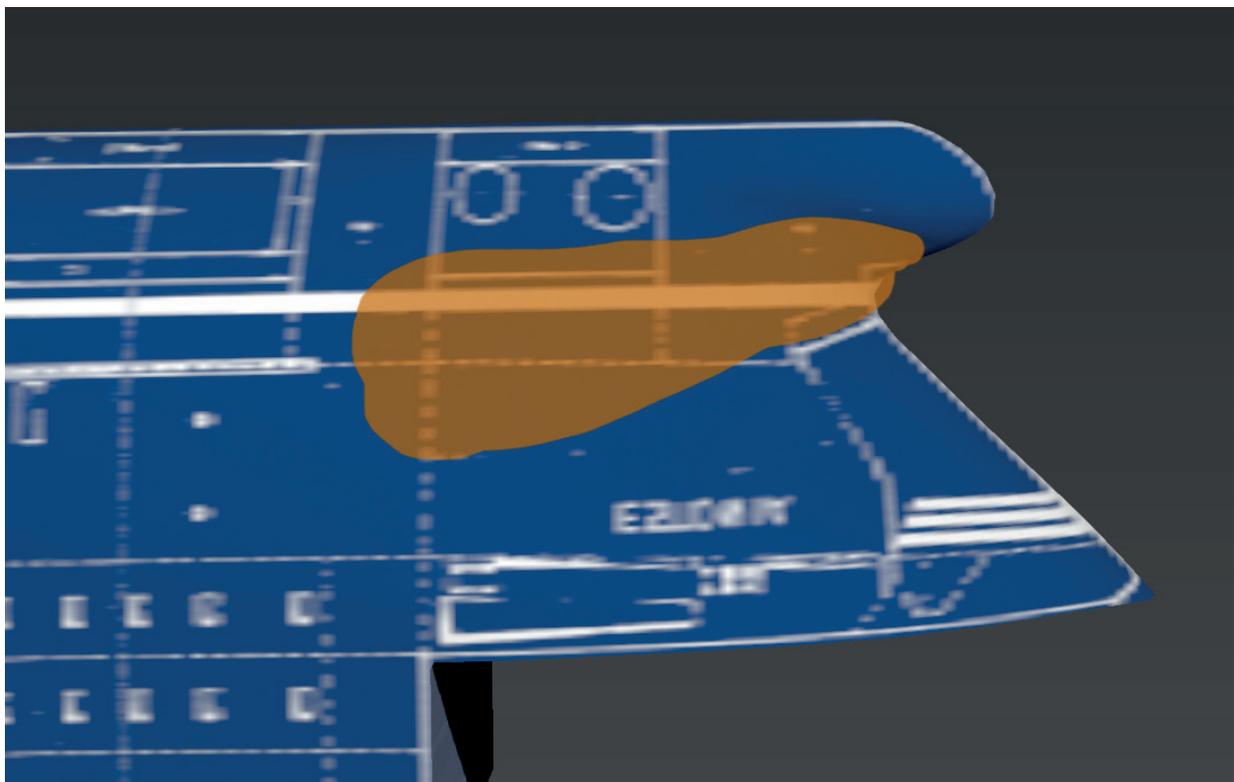
Parts of the bow area are covered with sand as shown below by Linus Andersson, LA Survey. This sand needs to be flushed away to be able to cover the entire ship with photogrammetry.

Graphic presentation Linus Andersson LA Survey showing area with sand covering parts of the hull near the bow.

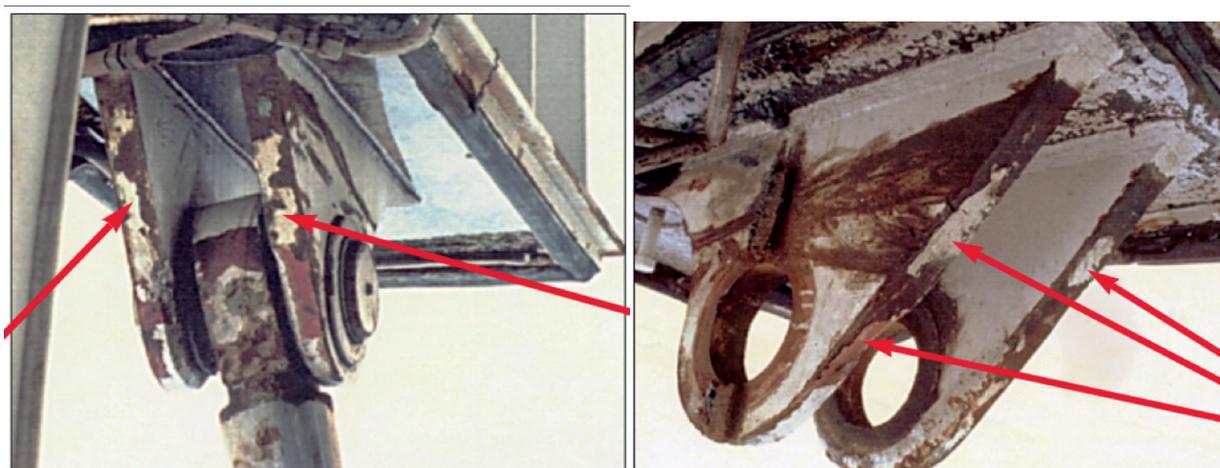
This investigation can clarify if the lugs, attaching the lifting cylinder to visor arm/hinge beam, have been torn off on both sides by the movements of the visor. This is the scenario presented but not proven by JAIC and it needs to be confirmed if this event is even possible and whether that is what occurred. The white paint on the surfaces of these lugs was still in place which indicates that this explanation might not be correct. There are alternative ways to explain the loss of visor other than the visor arm lugs cutting through the transverse deck beam.

Pictures above show the recovered port- and starboard lugs with paint still in place on surfaces that were said to have cut through a thick beam according to the JAIC investigation. This needs to be confirmed or rejected by a new investigation.

A modern FEM simulation or a practical experiment with hydraulic cylinder/actuator would show how many enacted 'wave' movements it would take to cut through a similar beam with such lugs. This could present investigators with a rough estimate of the time it would have taken Estonia to hit that number of waves. The time needed can be calculated based on the wave period at 4-meters significant wave height and the speed and direction of the Estonia. Indications of an explosion close to the lifting cylinder could be another way to explain the loss of the visor, as found in the GGE and IFG investigations.

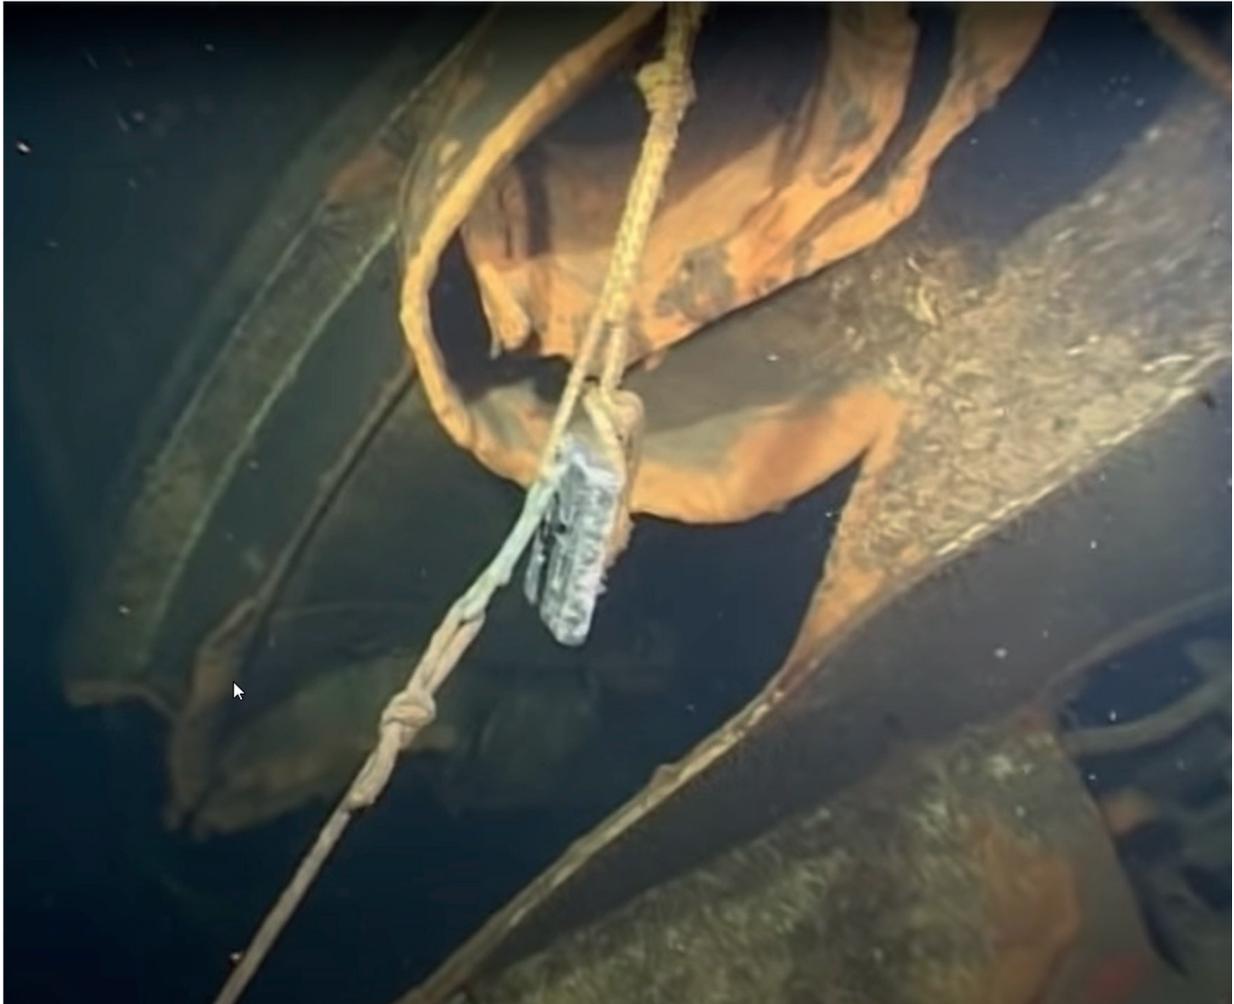
One area that needs to be documented with photogrammetry is the upper part of the bow of the Estonia. A new investigation needs to investigate the hole on the screen shot below. This film material comes from the Bemis/Rabe dive 19-31st of August in 2000 and uploaded to Youtube by Slawek Packo. The quality of this film material is very good compared to the material released earlier from the Swedish authorities.

This steel plate below has been rolled up and this needs to be analyzed by underwater blasting experts to conclude or reject if this steel plate has been ripped up by an explosion along the welds on the sides or if other forces can create this roll up. This plate of the ship also needs to be removed and metallurgically analyzed by explosions experts.
